## **Bathymetric and Velocimetric Surveys at Highway Bridges Crossing the Missouri River in and into Missouri during Summer Flooding, July–August 2011**

Scientific Investigations Report 2012–5204

By Richard J. Huizinga

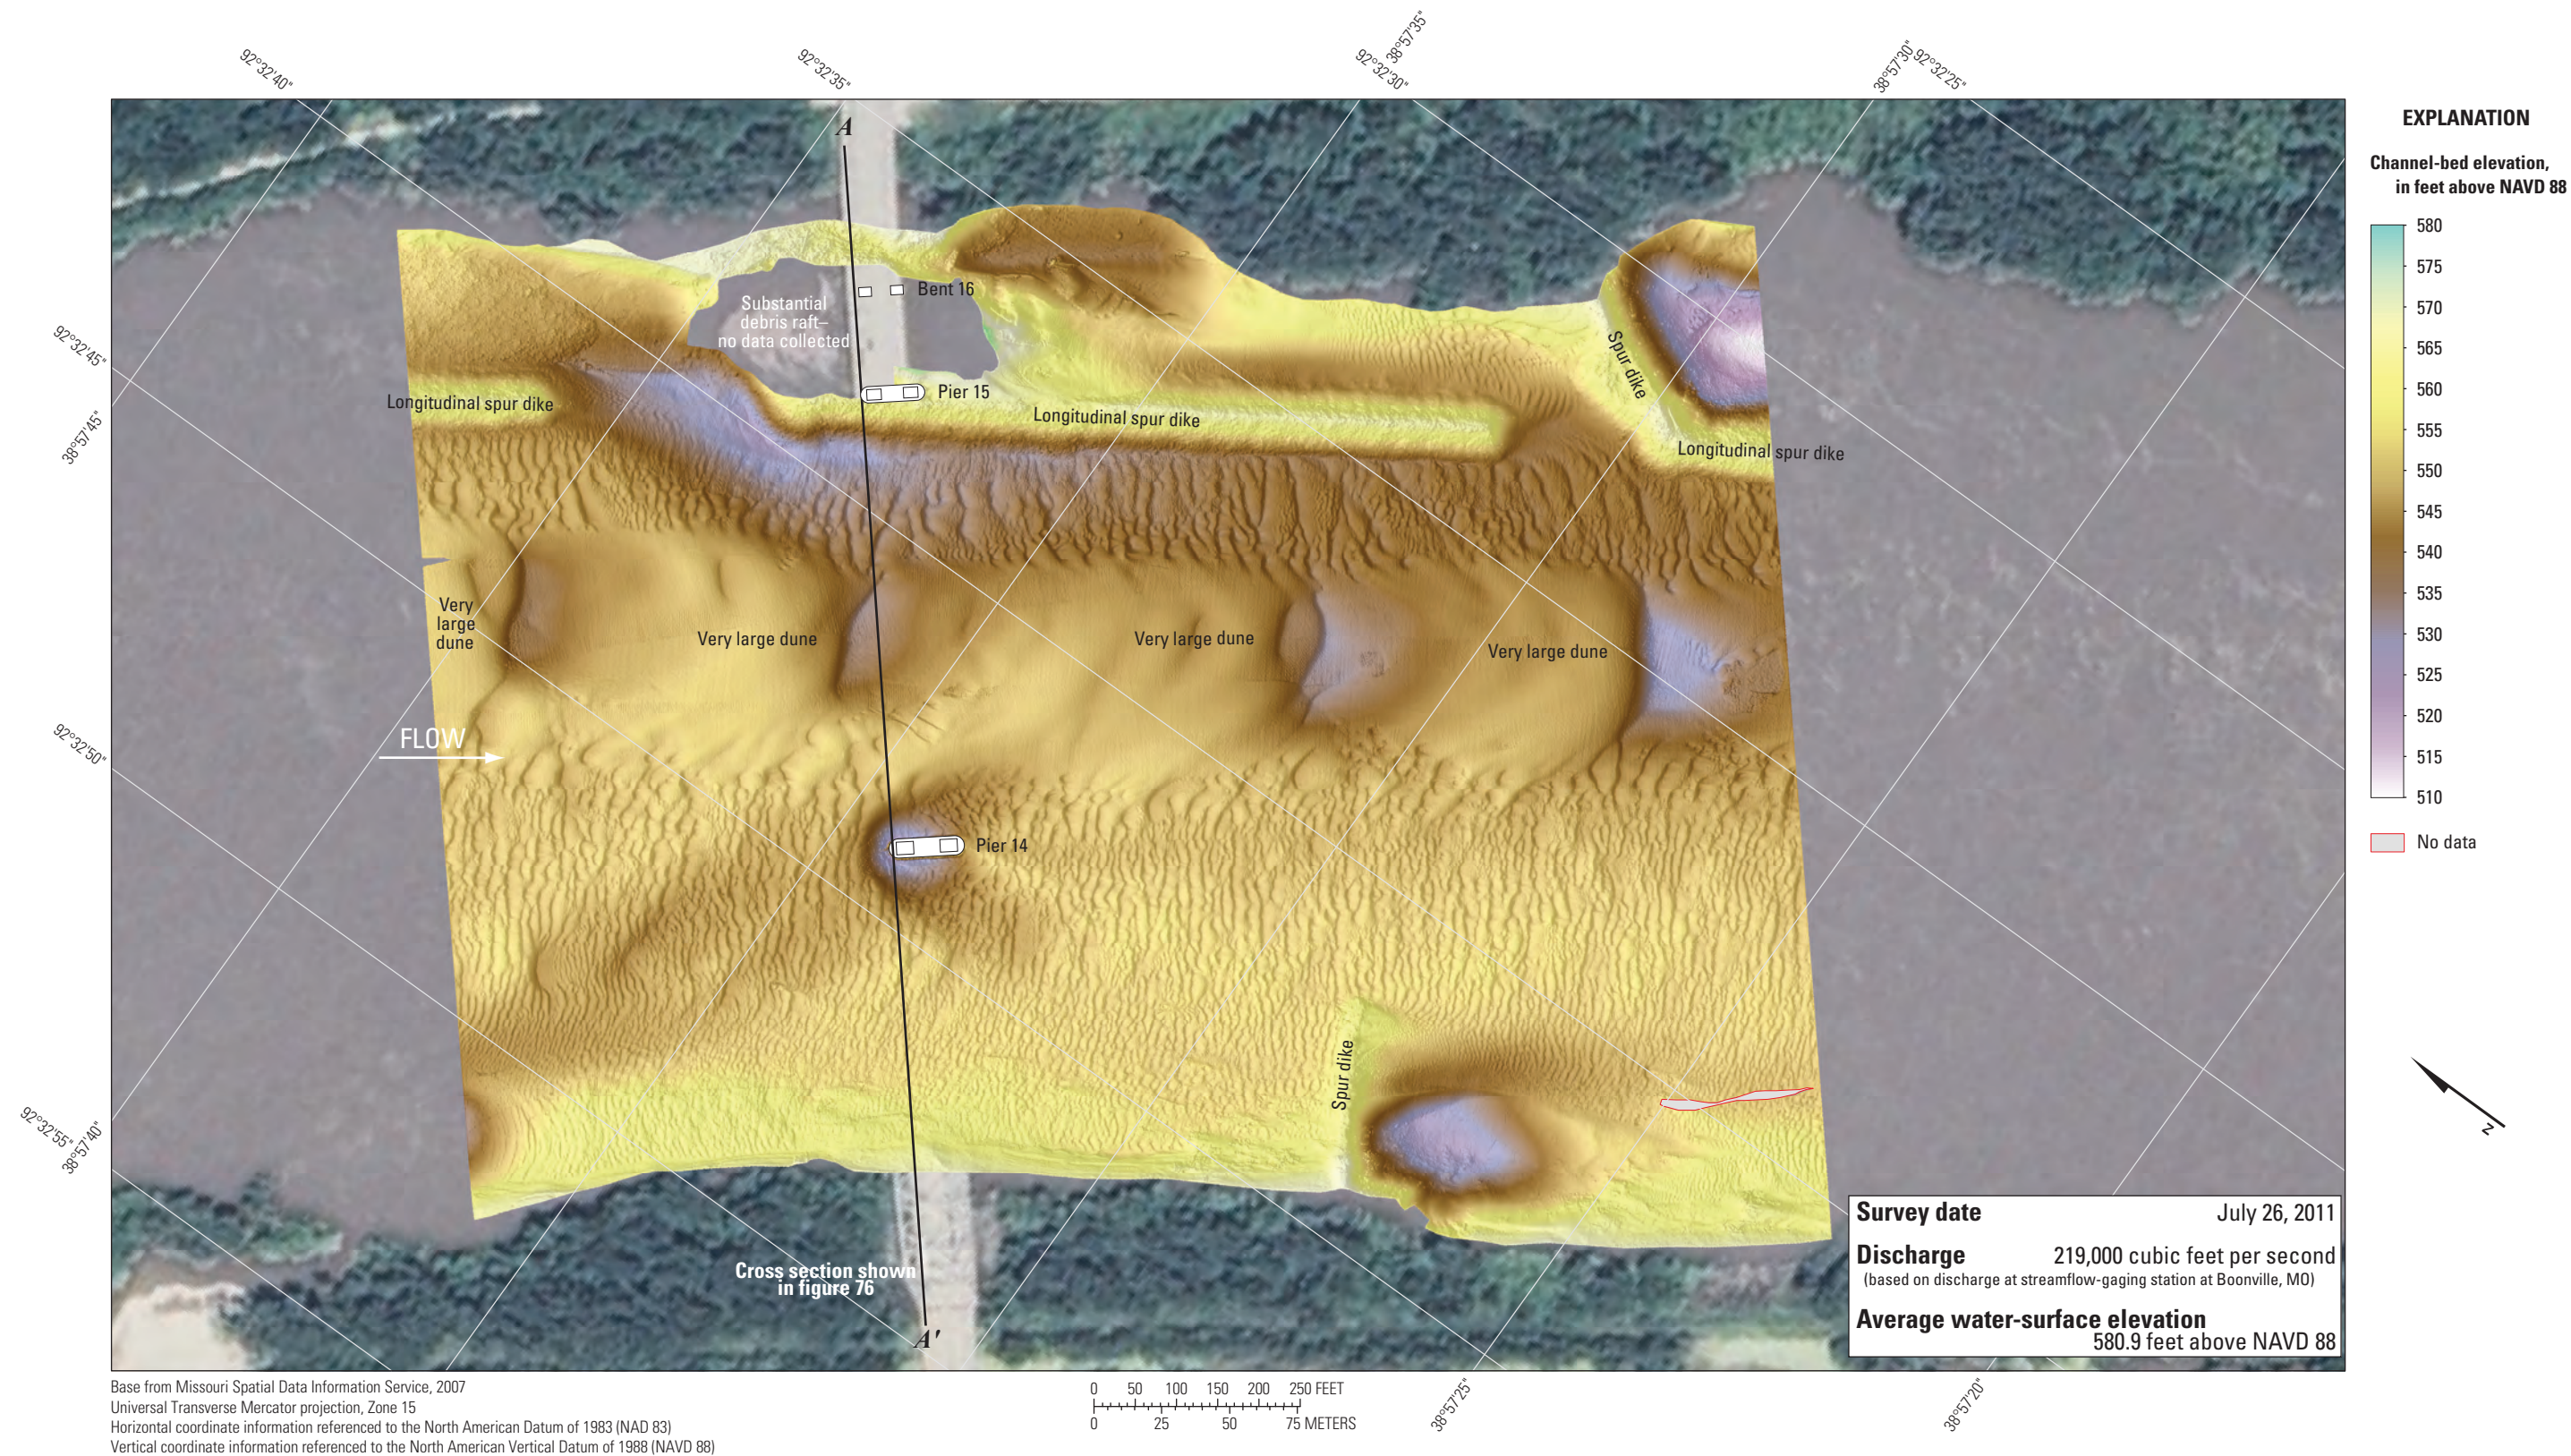
The survey area was about 1,640 ft long and about 1,180 ft wide, extending from bank to bank in the main channel (fig. 75). The upstream end of the survey area was about 580 ft upstream from the centerline of structure L0962 (fig. 62), and piers 14 and 15 and bent 16 were in the water. The channel-bed elevations ranged from about 534 to 560 ft for most of the surveyed area (5 to 95 percentile range of the bathymetric data), except near pier 14, in the channel thalweg along the left (north) bank and downstream from the various spur dikes (fig. 75). A series of very large dunes was present in the middle of the channel, and numerous medium and small dunes and ripples were present throughout the rest of the channel (fig. 75). Several longitudinal spur dikes were present on the left (north) bank, and a spur dike was present on the downstream right (south) bank (fig. 75). A substantial debris raft was present on the left bank between pier 15 and bent 16, which created a shallow area that extended from the upstream end of the longitudinal dike to a point about 125 ft downstream from structure L0962 for which no bathymetric data could be collected (fig. 75). A single survey swath was

In the vicinity of main channel pier 14 (fig. 75), a substantial scour hole had a minimum channel-bed elevation of about 525 ft (table 8), about 19 ft below the average channel elevation upstream from the bridge (fig. 76; table 8). Information from bridge plans indicates that pier 14 is founded on a caisson on bedrock, with about 27 ft of bed material between the bottom of the scour hole and bedrock (fig. 76; table 8). Pier 15 is embedded in the longitudinal spur dike, and the minimum channel elevation at the toe of the dike was about 530 ft (figs. 75, 76; table 8). Pier 15 also is founded on a caisson on bedrock, with about 11 ft of material between the minimum channel elevation and bedrock (fig. 76; table 8); however, the rock of the spur dike will limit or prevent a local scour hole near pier 15. Bent 16 is founded on a footing on bedrock, likely with 20 ft or more of bed material between the channel bed and bedrock based on the minimum elevation of the single survey swath obtained near bent 16 (fig. 76). The surveyed bed was substantially different from the ground line from the Level II bridge scour assessment in 2002, with as much as 20 ft of scour in the channel thalweg and as much as 10 ft of scour between pier 14 and the right bank (fig. 76).

Figure 75. Bathymetric survey of the Missouri River channel in the vicinity of structure L0962 on Interstate 70 near Rocheport, Missouri.

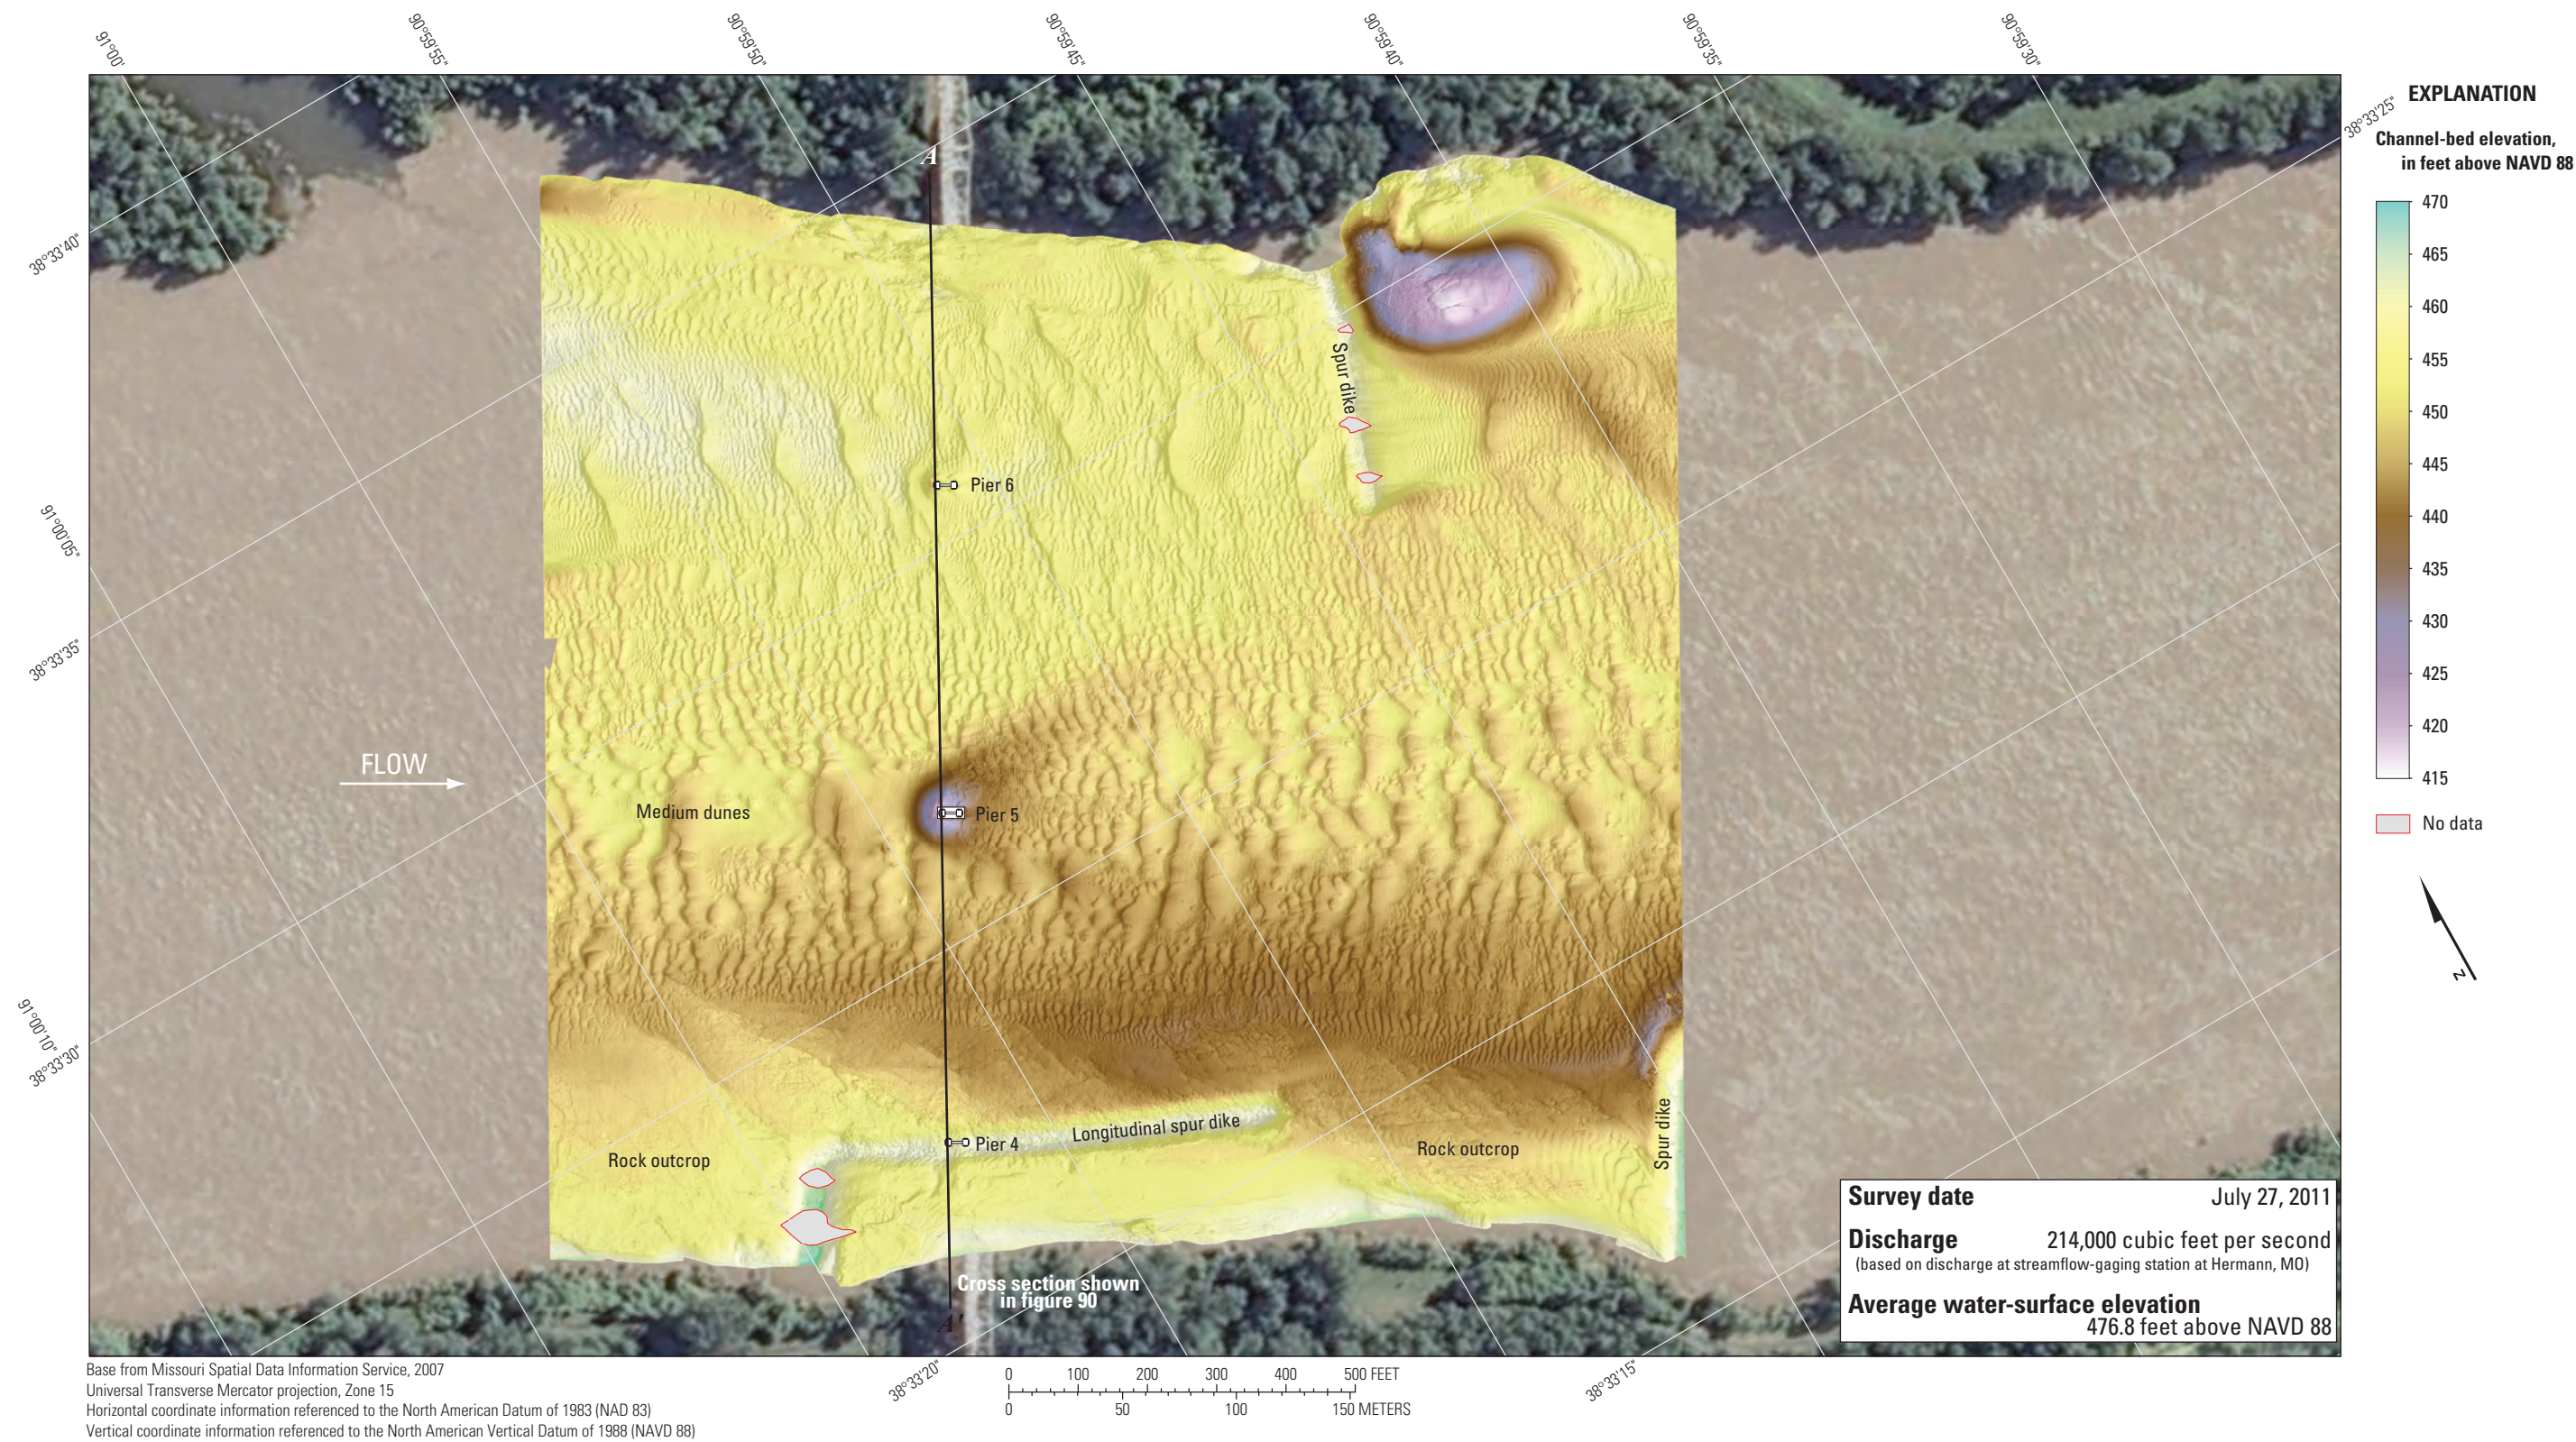
Scour holes were observed near piers 5 and 6. There was a substantial scour hole in the vicinity of main channel

pier 5 (fig. 89), with a minimum channel-bed elevation of about 423 ft (table 8), about 23 ft below the average channel-bed elevation upstream from the pier (fig. 90; table 8). The moderate scour hole near pier 6 had a minimum channel-bed elevation of about 446 ft (table 8), about 8 ft below the average channel-bed elevation upstream from the pier (fig. 90; table 8); this hole was more difficult to discern from nearby dunes (figs. 89, 90). Information from bridge plans indicates that piers 5 and 6 are founded on caissons on bedrock, with about 56 ft of bed material between the bottom of the scour hole and bedrock at pier 6, and about 30 ft of material at pier 5 (fig. 90; table 8). Pier 4 was embedded in the longitudinal spur dike, and the minimum channel elevation at the toe of the dike was about 448 ft (figs. 89, 90; table 8). Pier 4 is founded on a footing on bedrock, and bedrock was exposed at the toe of the spur dike (fig. 90; table 8); however, the rock of the spur dike likely will limit or prevent a local scour hole near pier 4. The surveyed bed generally was below the ground line from bridge modification plans (1993), with areas of substantial scour on the left side of the channel, near pier 5, and between piers 4 and 5 (fig. 90).

Figure 89. Bathymetric survey of the Missouri River channel in the vicinity of structure K0969 on State Highway 47 at Washington, Missouri.
